Manhole Inspection Summary

Manhole # S350__013MH

Insp Date: **1/24/08 11:29 AM**

Location Address: **e hanrietta**

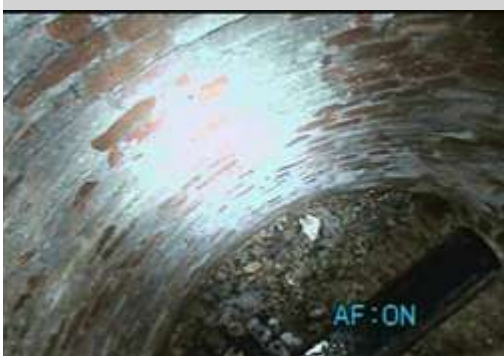
Defect 2

Condition: ☐ Sound ☐ Cracked ☐ Root Intrusion ☐ Deteriorated ☐ Leaks ☒ Debris

bench debris

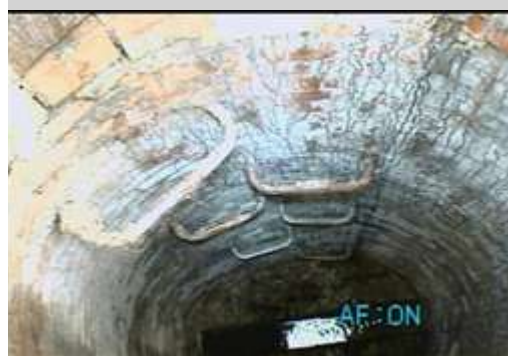
Defect 1

Steps Count: **6** Missing: **0** ☒ Corroded

corroded steps

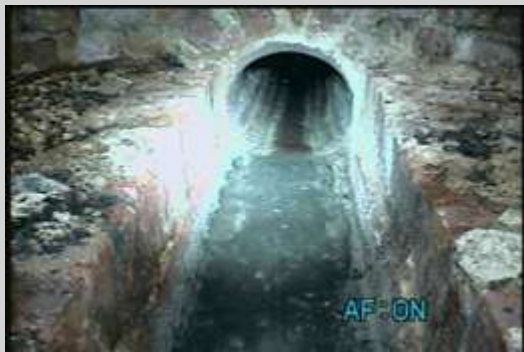
12 O'Clock Outflow

8 in. Circular Gravity Sewer
Pipe Out @ 12 O'Clock

Invert Depth: 11.10 (ft.) Flow Characteristics: **Slow**

Infiltration: **None** Pipe Seal Cond: **Unknown**

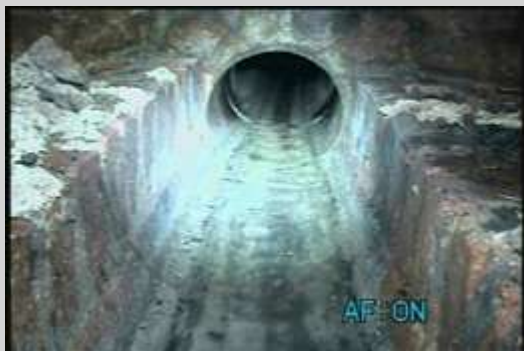
6 O'Clock Inflow

8 in. Circular Gravity Sewer
Pipe In @ 6 O'Clock

Invert Depth: 11.00 (ft.) Flow Characteristics: **Slow**

Infiltration: **None** Pipe Seal Cond: **Unknown**
